**TRANSPORTATION SCIENCES
CRASH DATA RESEARCH CENTER**

**VERIDIAN ON-SITE
SIDE IMPACT CURTAIN DEPLOYMENT FATALITY /
EVENT DATA RECORDER EQUIPPED VEHICLE INVESTIGATION**

VERIDIAN CASE NO. CA01-044

VEHICLE - 2001 SATURN SL1

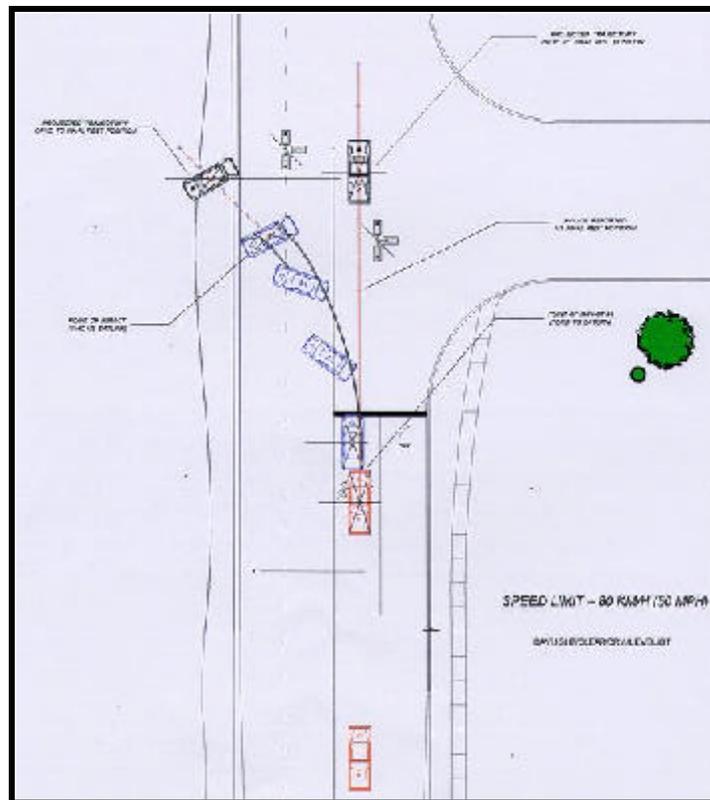
As the Ford Explorer (V1) approached the 3-leg intersection, the front left area impacted the rear right area of the Saturn SL1 (V2) which resulted in moderate damage to the Ford and severe damage to the Saturn (**Figure 3**). Pre-impact braking by the Ford Explorer was confirmed by the variance in bumper heights between the two vehicles, and lack of associated override/underride damage sustained. The point of impact was confirmed by tire marks and gouge marks documented at the crash site. Although the involved drivers could not recall the specific phase of the overhead traffic control, physical evidence and vehicle recorded speeds suggested that the light was in a steady green phase as *northbound* congestion slowed traffic to a sluggish pace. The Saturn's EDR logged a vehicle speed of 12.9 km/h (8.0 mph) one second prior to the crash which, when compared to the following interval, equaled an acceleration rate of 30.6 km/h (19.0 mph).

Figure 3. Impact #1 schematic - (V1) Ford vs. (V2) Saturn.

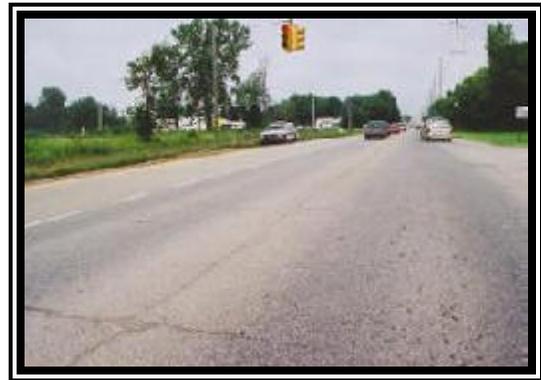
At this point, the Saturn (V2) rotated 115 degrees counterclockwise and traveled 18.6 meters (61.0 feet) along its post-impact trajectory into the southbound lanes (**Figure 4**), and across the path of the southbound 2001 GMC Yukon (V3). The Saturn's pre-impact trajectory was evidenced by 20.7 meters (67.9 feet) of yaw marks identified at the scene. As the Saturn crossed the outboard (southbound) lane, the right passenger area was impacted by the frontal area of the GMC resulting in severe damage to the Saturn

Figure 4. Northwest post-impact trajectory for the 2001 Saturn SL1 (V2).

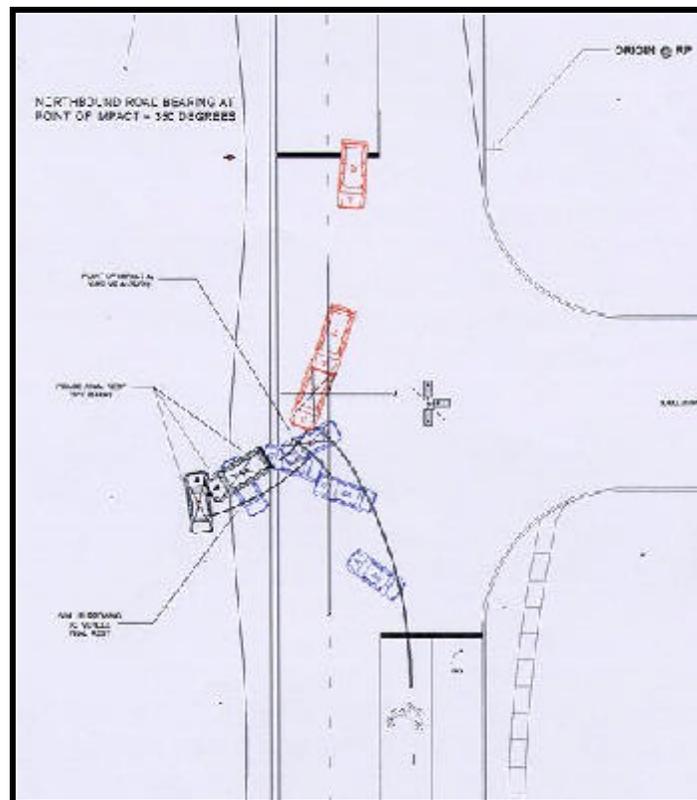
Figure 5. Impact #2 schematic - (V3) GMC vs. (V2) Saturn.

and minor damage to the GMC (**Figure 5**). The WinSMASH trajectory algorithm computed speeds *at impact* of 68.9 km/h (42.8 mph) for the Saturn and 16.0 km/h (9.9 mph) for the striking GMC. Computed velocity changes were 33.9 km/h (21.1 mph) for the Saturn and 16.5 km/h (10.3 mph) for the striking GMC. The Saturn's latitudinal component was 16.9 km/h (10.5 mph) as the GMC's longitudinal component was -16.2 km/h (-10.1 mph). Impact induced deceleration was not sufficient to deploy the GMC's redesigned frontal air bag system, however, the Saturn's right side impact curtain did deploy. The Saturn's EDR recorded a near deployment event (see **Figure 20 - page 17**). Although the obtuse nature of the impact configuration resulted in initial engagement along the front left and center sections of the GMC, subsequent spin out contact (or clockwise rotation of the Saturn) engaged the remainder of the end structure during post-impact travel. The vehicles sustained contact 9.7 meters (31.8 feet) in a southwesterly direction to final rest off the west shoulder with the Saturn facing northwest and the GMC facing southwest (**Figure 6**). This post-impact trajectory was evidenced by 8.6 meters (28.2 feet) of scuff marks and soil furrowing identified at the crash site.

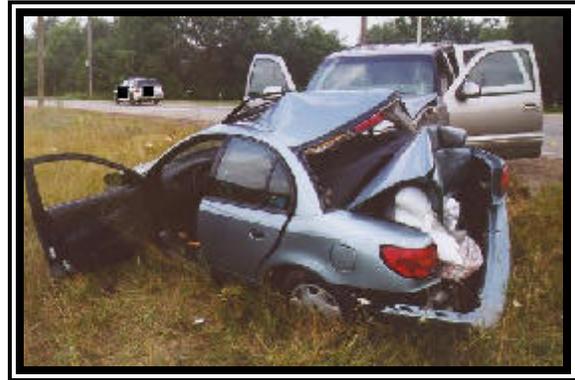
Figure 6. Police photo northeast of the 2001 Saturn (V2) and 2001 GMC (V3) final rest position.

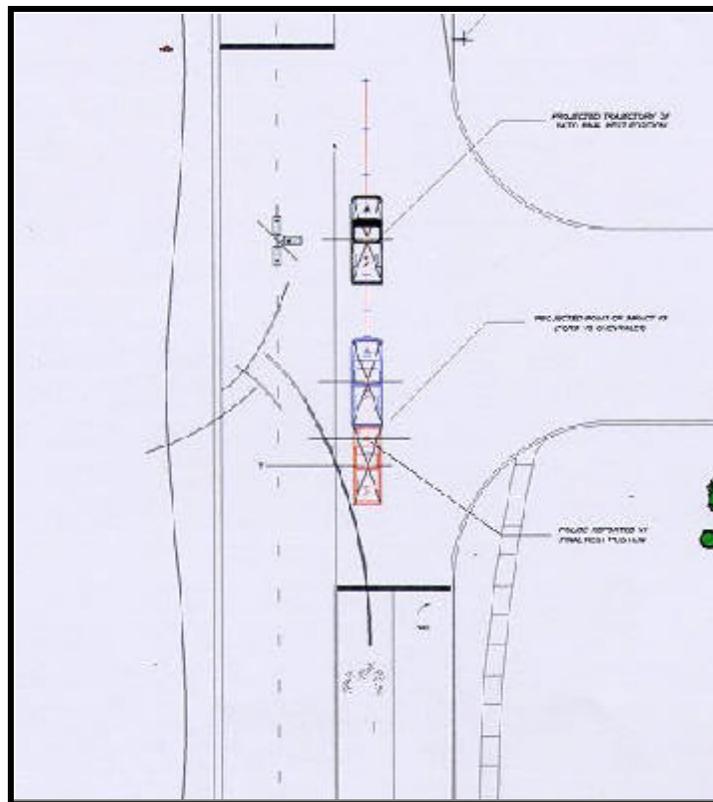
Figure 7. Impact #3 schematic - (V1) Ford vs. (V4) Chevrolet.

15.8 meters (51.8 feet) as the frontal area struck the rear area of the 2000 Chevrolet K-1500 Silverado pickup truck (V4) which resulted in minor damage to both vehicles (**Figure 7**). The WinSMASH trajectory algorithm computed speeds *at impact* of 36.0 km/h (22.4 mph) for the Ford and 11.4 km/h (7.1 mph) for the struck Chevrolet, with respective matching negative and positive longitudinal values. The Ford traveled 1.8 meters (5.9 feet) to final rest in the northbound lane (**Figure 8**) as the Chevrolet was driven approximately 28.4 meters (93.2 feet) to final rest off the east shoulder in the northeast sector of the intersection (**Figure 9**).

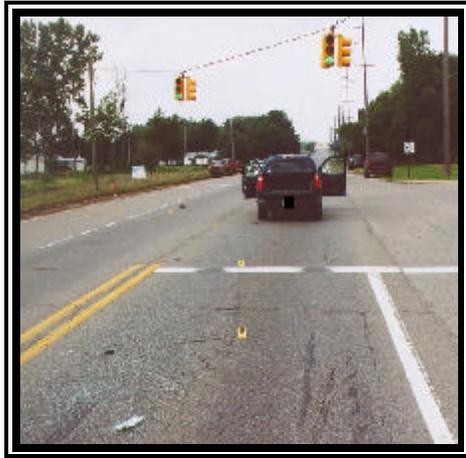
Figure 8. Police photo north of the 2001 Ford Sport-Trac (V1) final rest position.

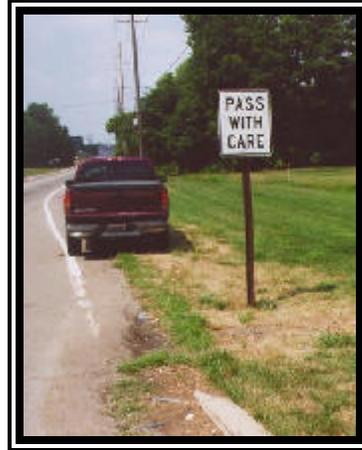
Figure 9. Police photo north of the 2000 Chevrolet pickup (V4) final rest position.

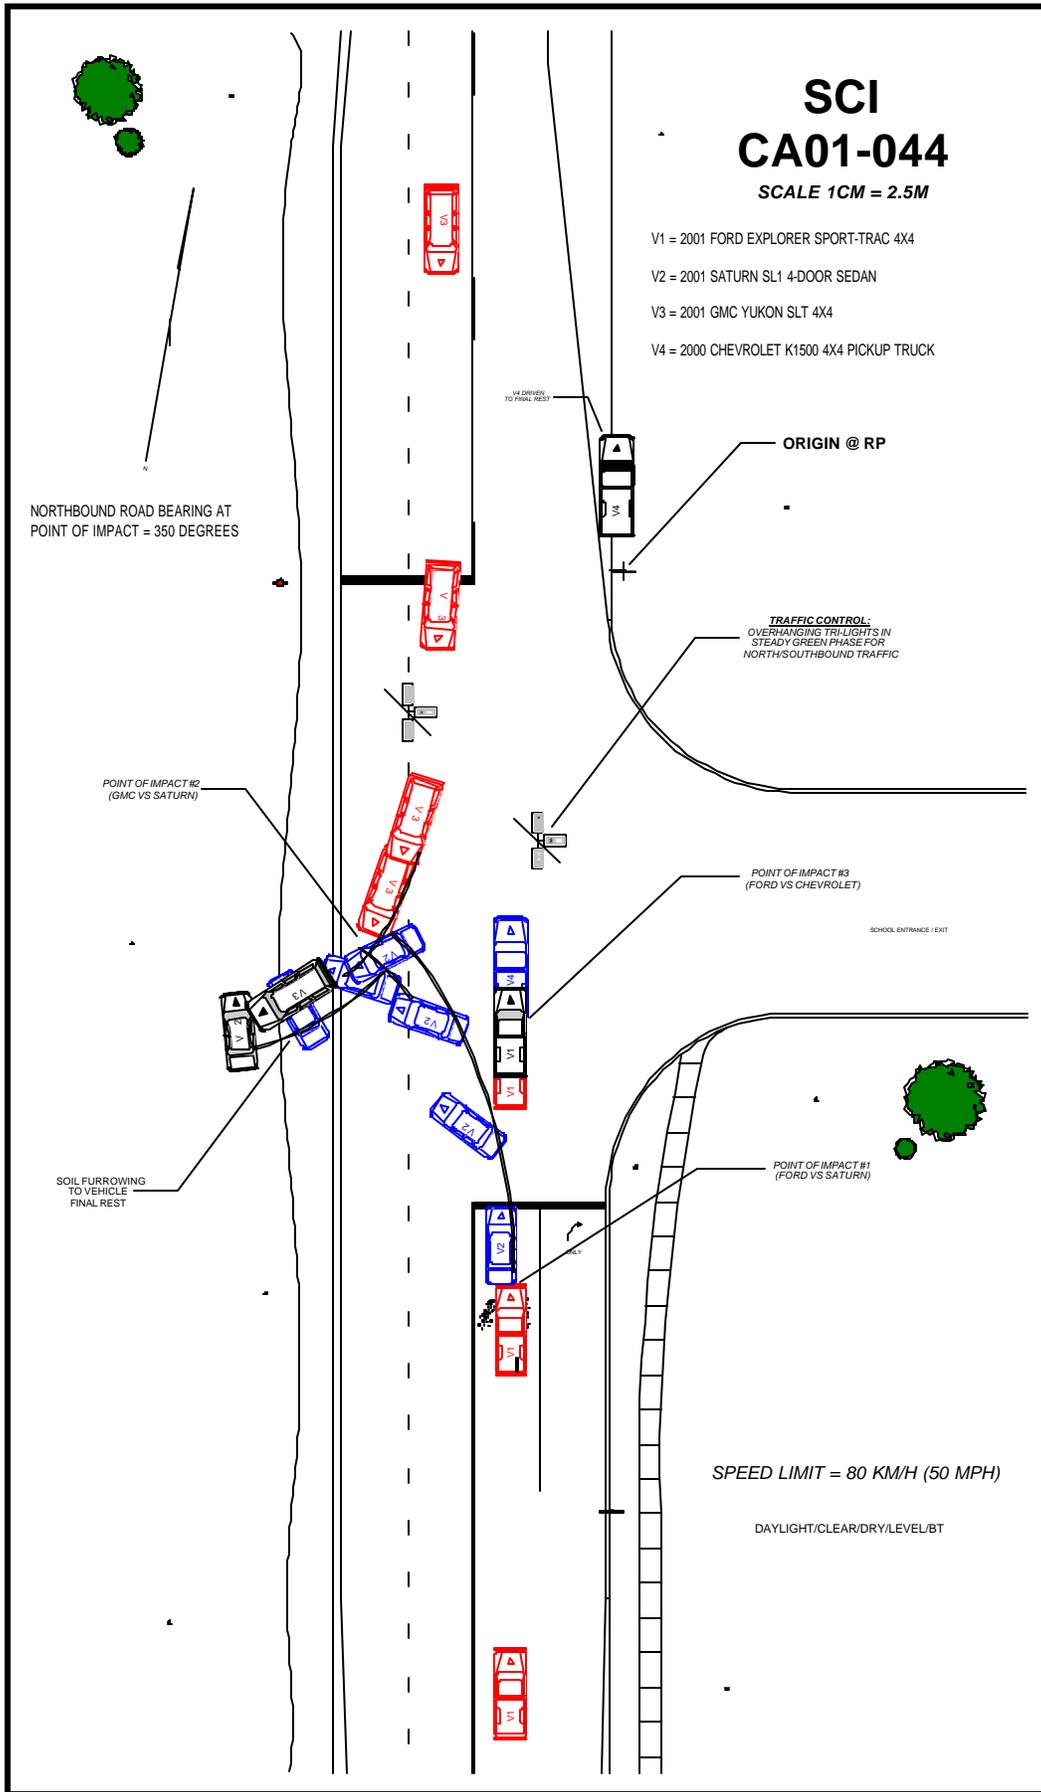
Figure 19. Scene Diagram (impacts #1-3).

This four vehicle crash occurred during the afternoon hours of July, 2001. At the time of the crash, it was daylight with no adverse conditions as the roads were dry. The crash occurred at a (straight/level) 3-leg intersection between a local artery and an elementary school driveway (see **Figure 19 - page**
